Rebuilding a 13.5 MW hydro generator

Sulzer uses latest brazing technology in round-the-clock generator overhaul project for Statkraft. Hydropower generation sites across the UK have been delivering clean and renewable energy for decades. To ensure continued reliable operation, major components, such as generators need to be overhauled to prevent unexpected downtime. When the generator at the Dinas power station developed a fault, the project to refurbish the generator was awarded to Sulzer.

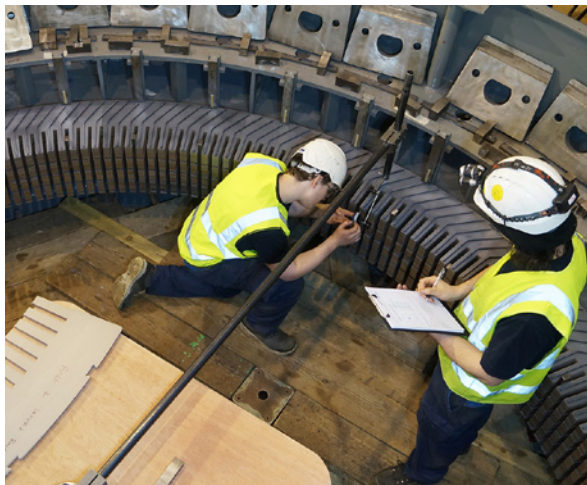
Sulzer rebuilt the core concentric to within 0.15 mm and circular from top to bottom to within 0.05 mm

Having established that the stator core would need to be replaced as well, Sulzer was essentially left with the generator frame as the starting point. The new core was built up using sectioned laminations to create a complete assembly without any gaps. In fact, Sulzer rebuilt the core concentric to within six thousandths of an inch (0.15 mm) and circular from top to bottom to within two thousandths of an inch (0.05 mm); a considerable improvement on the original.

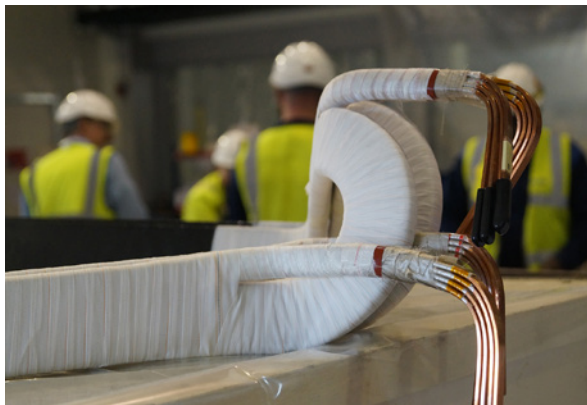
Spare coils were manufactured for Statkraft as part of the project

In all, 227 new coils were designed, manufactured and tested in Sulzer's Birmingham Service Center. Of these, 216 were destined for the stator, with two spares for the build team and five spares for the customer. The remaining four coils were tested to destruction according to the specifications for hydro-electric applications and subjected to some of the most arduous test routines.

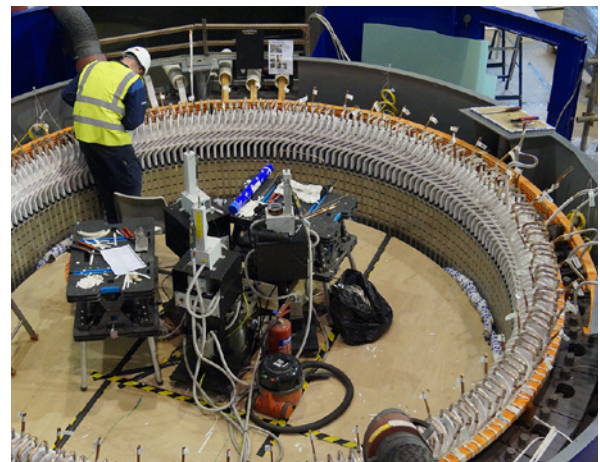
The hydrogen brazing stations (center) saved six days on the rebuild time

Sulzer has invested in the latest in hydrogen brazing technology, which not only saved six days on the rebuild time, but is also less demanding in terms of health and safety requirements. Traditional oxy-acetylene brazing uses lower temperatures, requires a set of gas bottles for each brazing station and the process produces fumes that need to be extracted away from the working area. In contrast, hydrogen brazing uses increased temperatures and produces water as the only by-product.

The process uses a hydrogen generator, which converts water to hydrogen gas that is supplied to a number of brazing stations. The higher heat concentration speeds up the brazing process and means that there is no need to reinstate the insulation after it has been completed, saving time for the project. In this case, three brazing stations were set up in the center of the stator, allowing the coil connection process to be completed much quicker.
